Kinder Park Hall
(National Trust
High Peak Estate)
Hayfield
Derbyshire

Archaeological Survey

**KINDER AND PARK HALL
(NATIONAL TRUST HIGH PEAK ESTATE),
HAYFIELD, DERBYSHIRE**

ARCHAEOLOGICAL SURVEY 1999

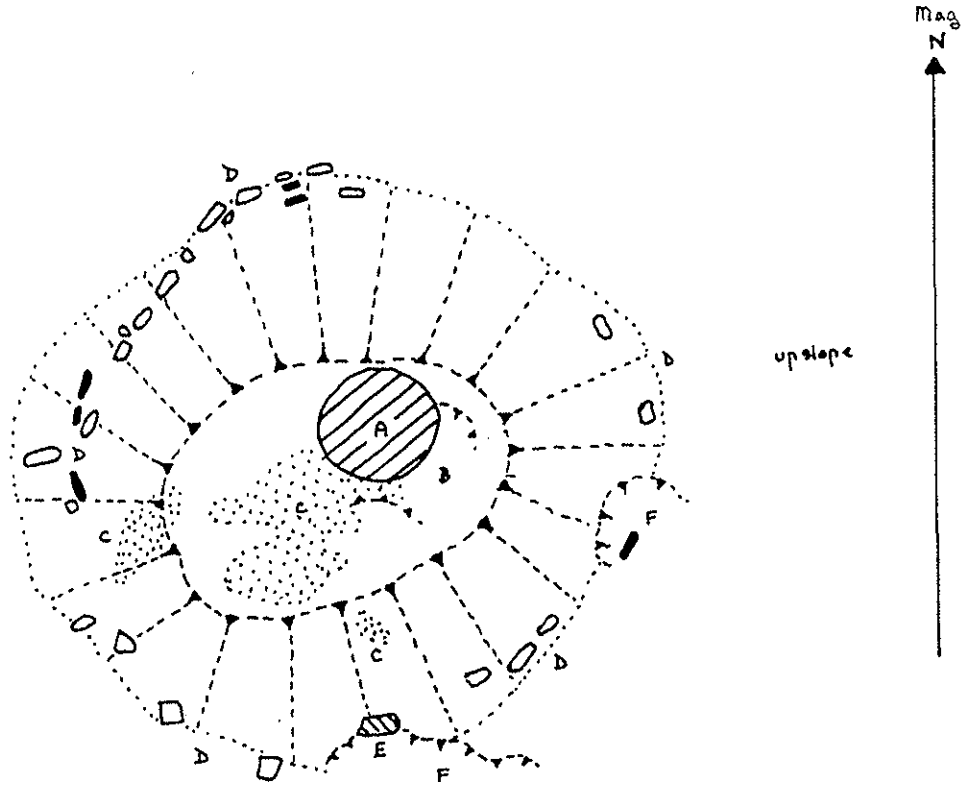
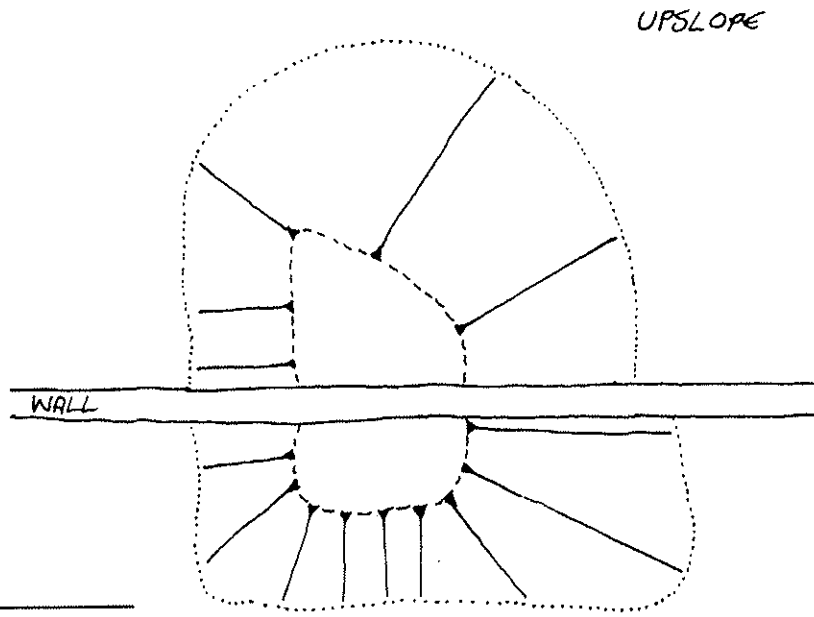
KEY
Above: Kinder Low burial barrow (feature 46)
A: Modern cairn, B: Slight cairn, C: Erosion
caused by superficial robbing, D: Kerb,
E: Possible earthfast boulder, F: Peat erosion
Below: The Ashes possible burial barrow
(feature 115)

It is a type of barrow built during the later Neolithic to earlier Bronze Age, approximately 3500 to 4500 years ago, as a location for burying the dead. Many similar barrows in the Peak District were constructed containing cremations placed in urns or inhumations (Barnatt 1996). No burials have been found and no archaeological excavations have been recorded however a small sherd of prehistoric beaker pottery from this period was found near by (Potter 1987).

The barrow is an important site which forms part of the significant regional group of later Neolithic to earlier Bronze Age burials barrows in the Peak District (see Barnatt 1996??). It is a Scheduled Ancient Monument (SAM number 23271). Any damage or disturbance to the site is illegal without scheduled monument consent from the Department of Culture, Media and Sport (as at 2000).

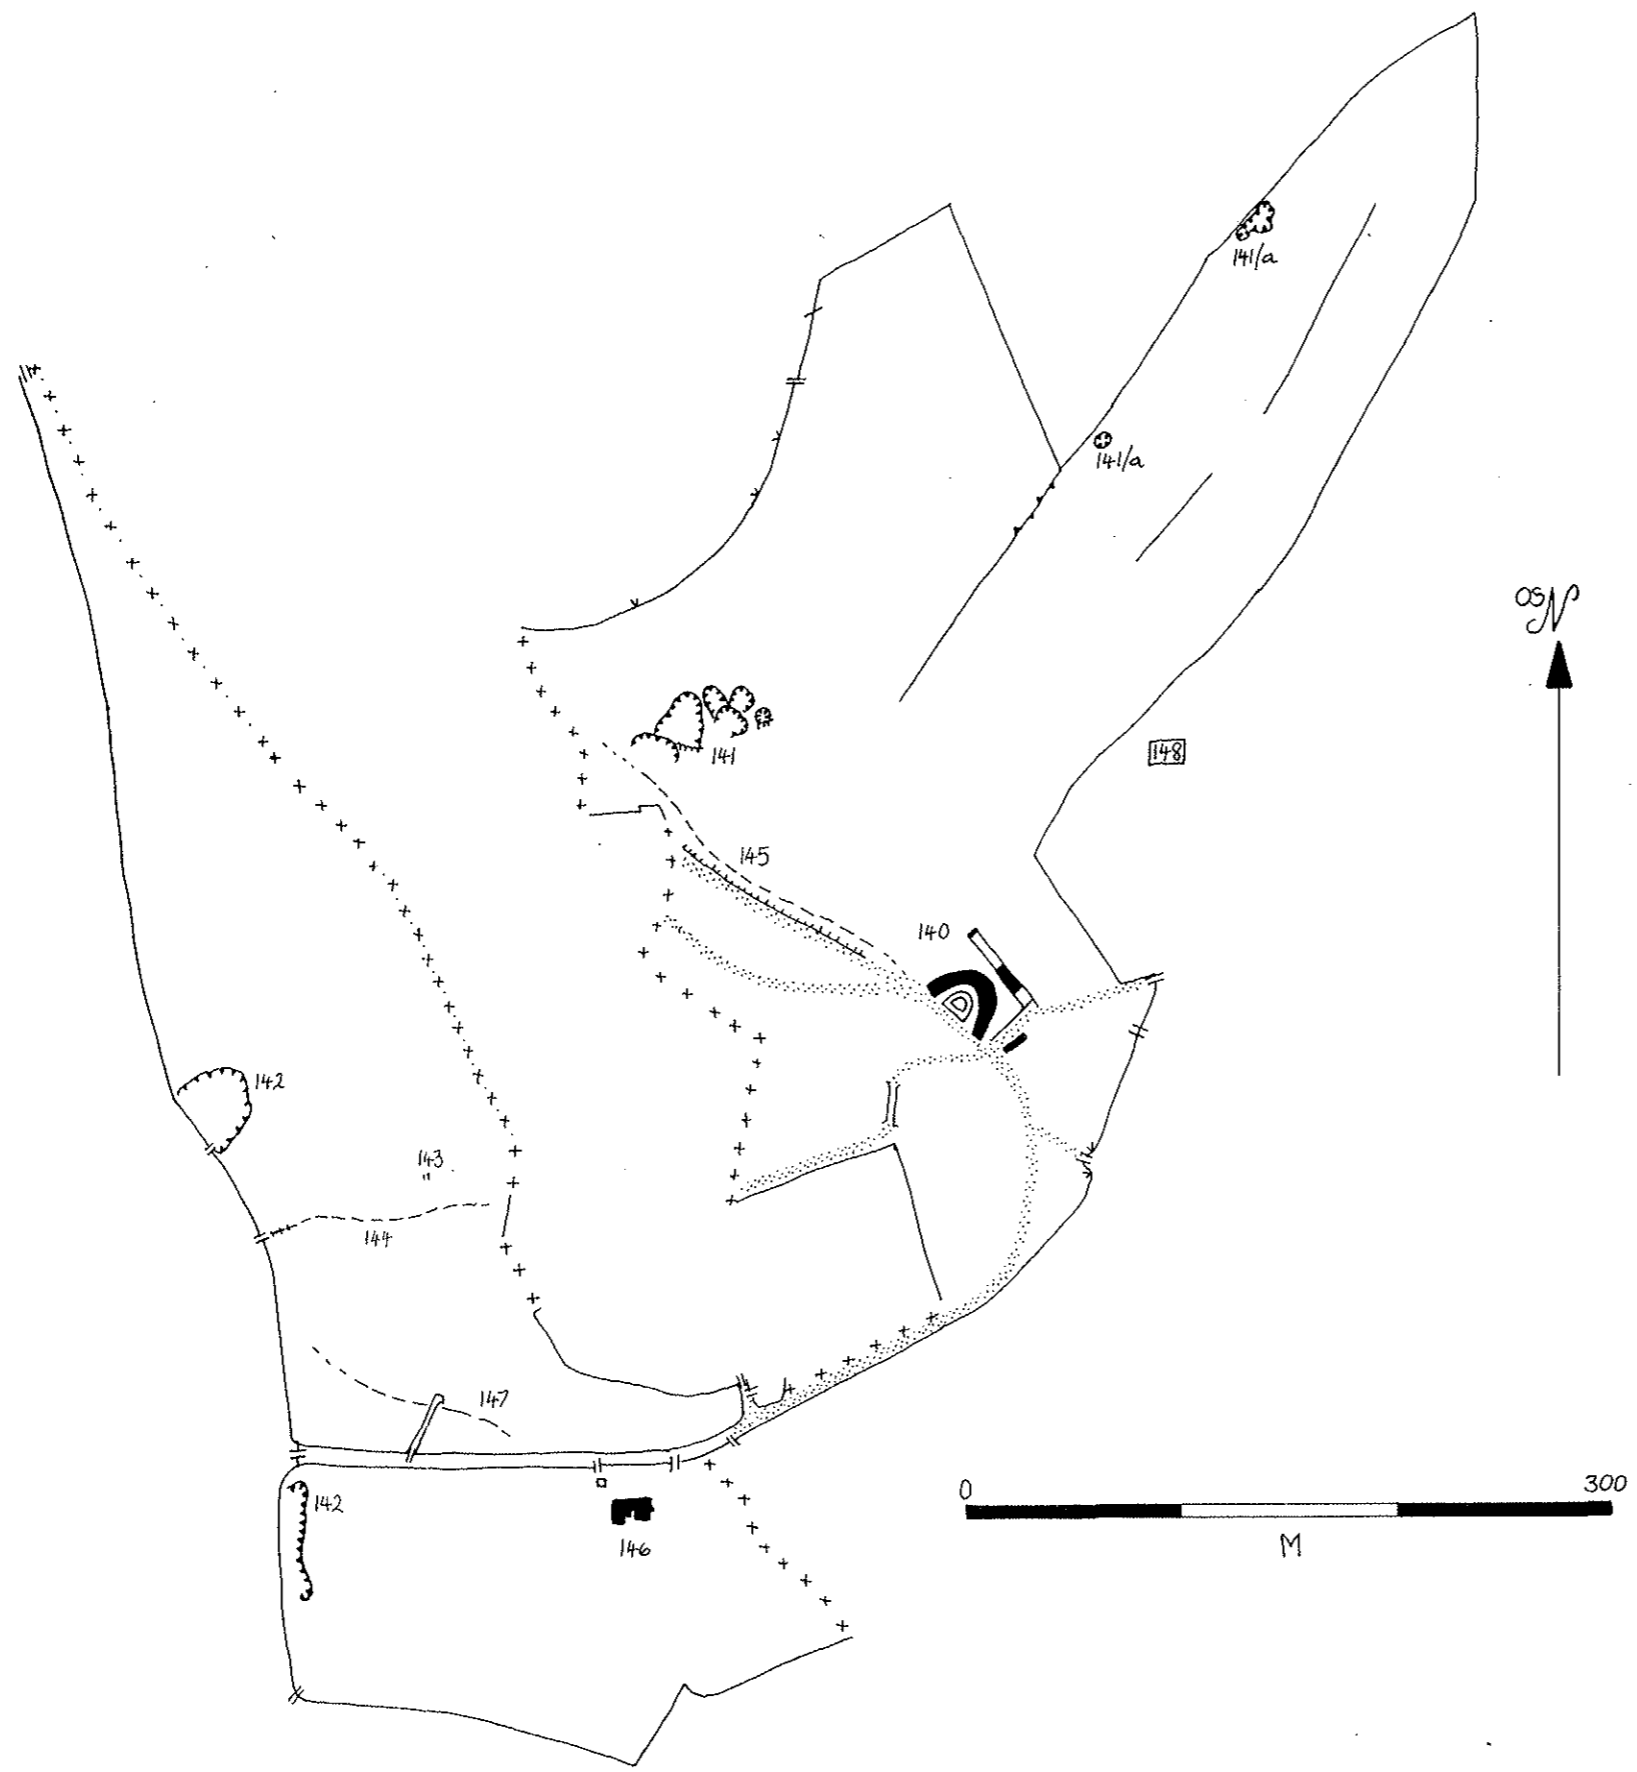
PROJECT:
 KINDER AND PARK HALL
 ILLUSTRATION NO. 17
 TITLE: ARCHAEOLOGICAL
 FEATURES - PARK HALL
 FIELDWORK DATE: AUG.-
 OCT. 1999
 DRAWING DATE: DEC. 1999
 DRAFTSPERSON: WJB
 REF.

Two-storey stableblock built in the early 19th century and converted to houses in the mid-20th century. Built from coursed squared gritstone with ashlar dressings and quoins (some rusticated). The roof is slate with lead ridges and pedimented gables. Central to this is a stone cupola with openings, louvres and topped with ball finial and weathervane. In the west
