Site code: FMF/DA/05

Canterbury Archaeological Trust Ltd

October 2005

FAIRLIGHT AND MARSHAM FARM, EAST SUSSEX: SURVEY AND ASSESSMENT

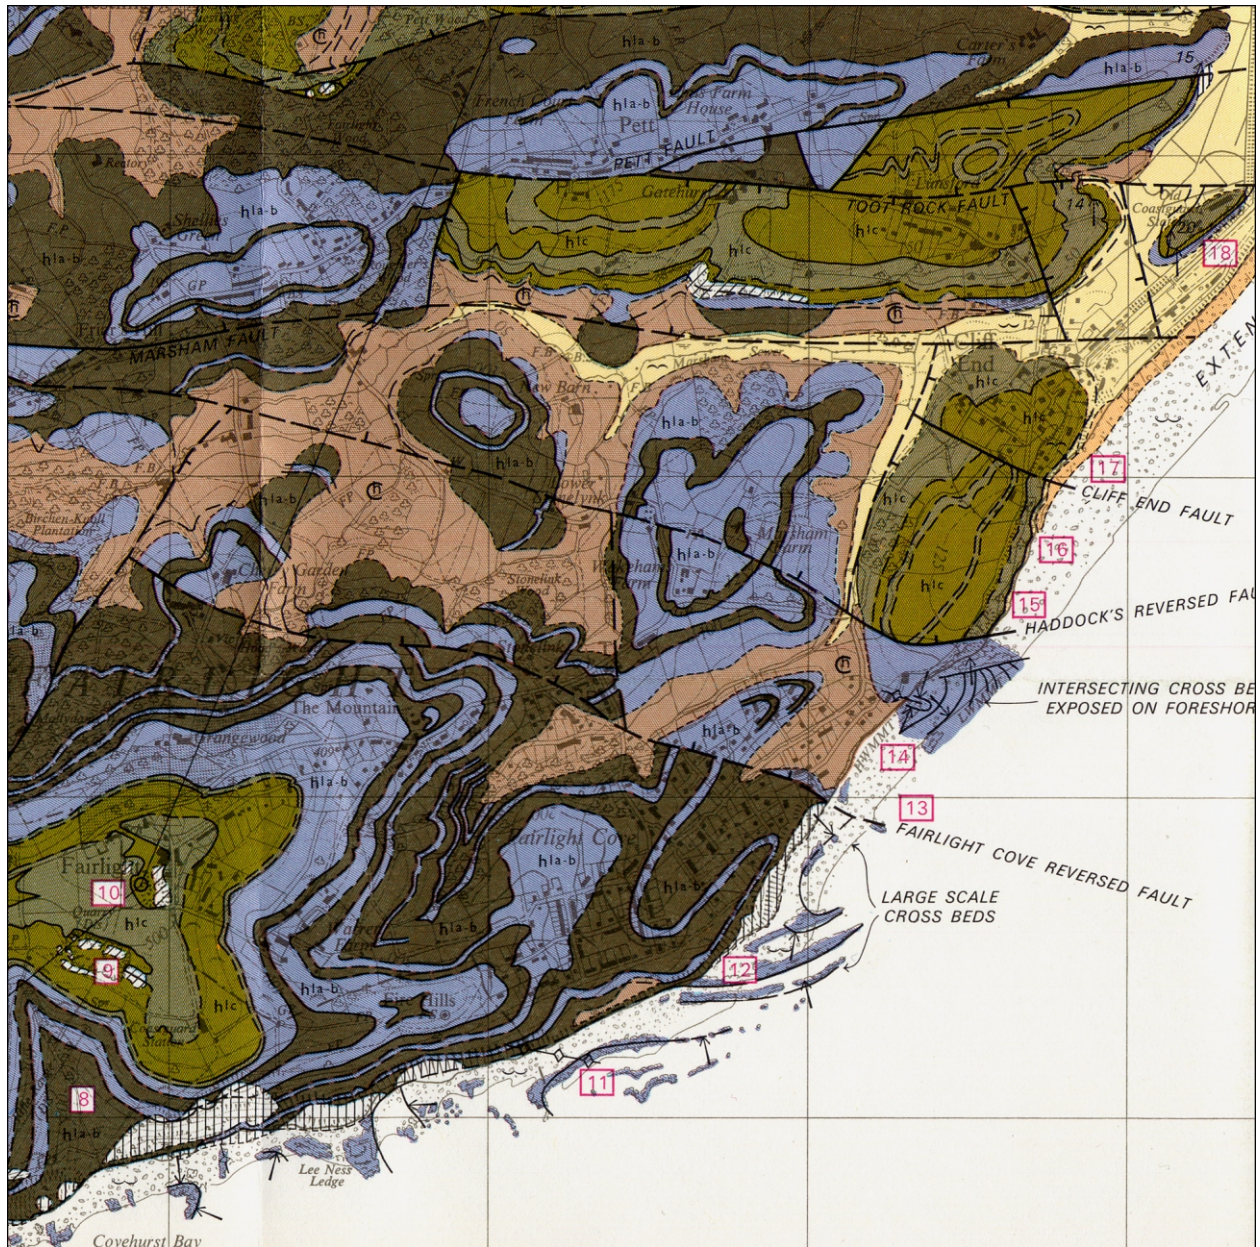
1.6.3 Fairlight and Marsham Farm lie on the Wadhurst Clay and Ashdown Beds which here contain, respectively, bands of sand and bands of clay (Fig 3). The area is heavily faulted, the Haddock's Reversed Fault actually visible as a topographical feature on the southern side of the Fairlight hill above Fairlight Cove (Lake and Shepherd-Thorn 1987, 66-7). On the north-east of the hill another north-west tending fault, the Cliff End Fault, lies on the boundary of the property. The main valley on the north side of the property, below Pett Road, is on the line of the Marsham Fault while the small valley extending south-west towards Old Marsham Farm lies on another fault. Both valleys are occupied by areas of Head and Alluvium.

Fig. 3. 1:50000 Geological Survey, parts of Hastings and Dugeness Sheet 320/321 British Geological Survey (1980).

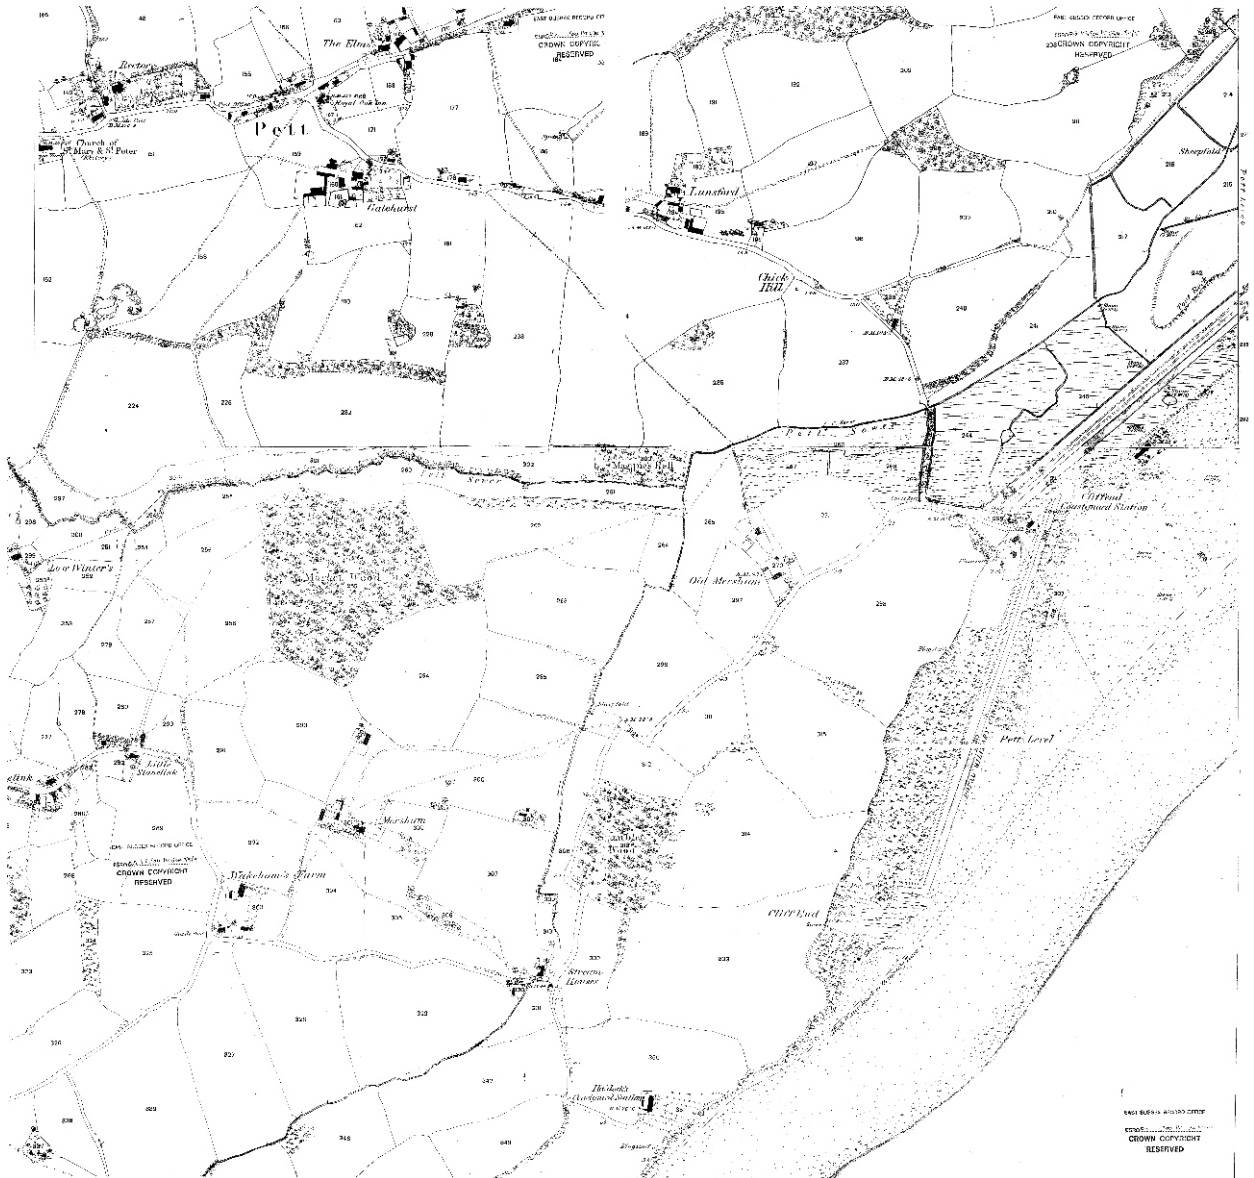
It should be noted that the area now occupied by the sewage works, outside the National Trust property, is shown on the 1873 Ordnance Survey map as the site of two buildings (Fig 4). These were presumably ancillary farm buildings which had disappeared by 1936, their site destroyed in the construction of the sewage works.

Fig. 4. First edition Ordnance Survey 1:2500 map, 1873.

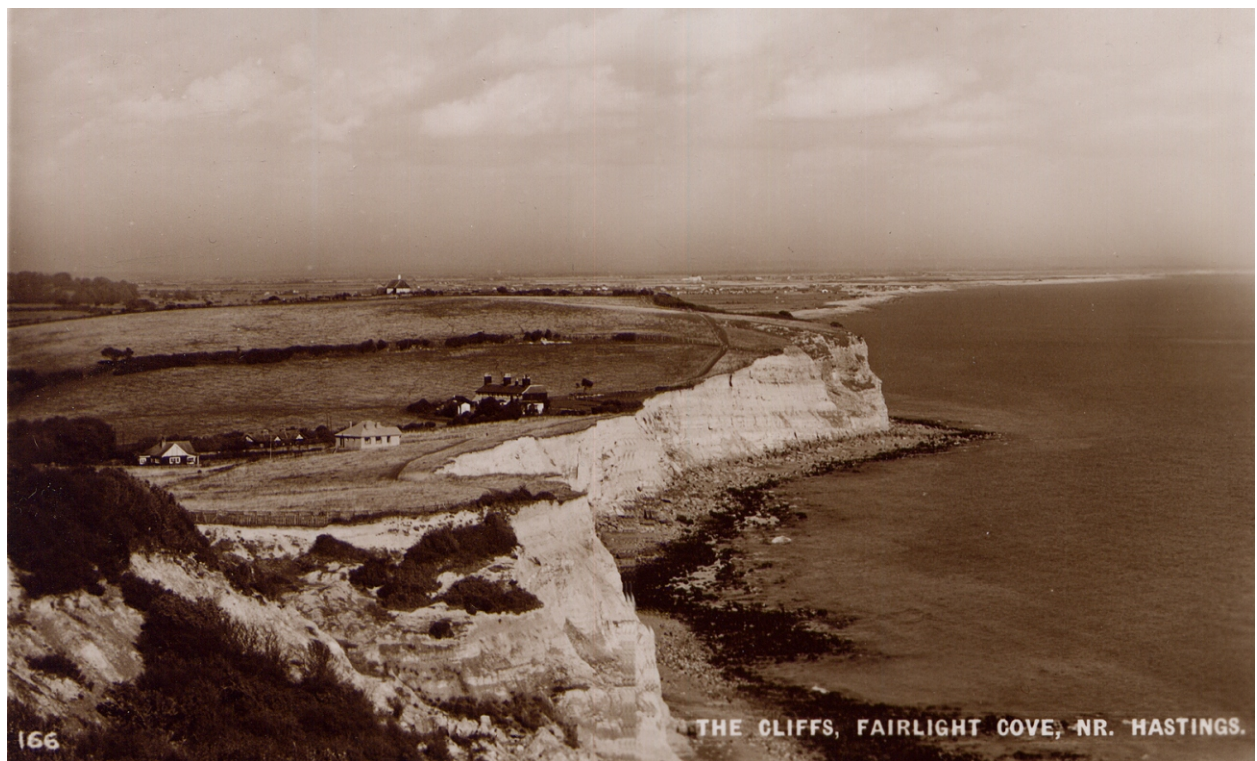
Plate 1. View of Fairlight Hill and cliffs from the south-west, showing extent of erosion near Haddock's Cottages in the (?)1930's.

Although much of the cliff is of a fairly durable sandstone, undermining by the sea and collapse of the cliff face appears to have taken place on the north-eastern edge of the property. The main erosion has, however, occurred on the south-east, near Haddock's Coastguard cottages which have now largely collapsed over the cliff edge. Coastal defences have here been strengthened but the present cliff edge is still subject to collapse, probably through the effect of rain and frost action on the softer clay, blocks of the cliff edge having slumped towards the beach. Comparison of Figures 2 and 4 shows the extent of erosion here over the period 1873 -2000. The cliff edge should be monitored for coastal loss following periods of storm and high rainfall and mitigation measures put in place if archaeological loss is apparent.

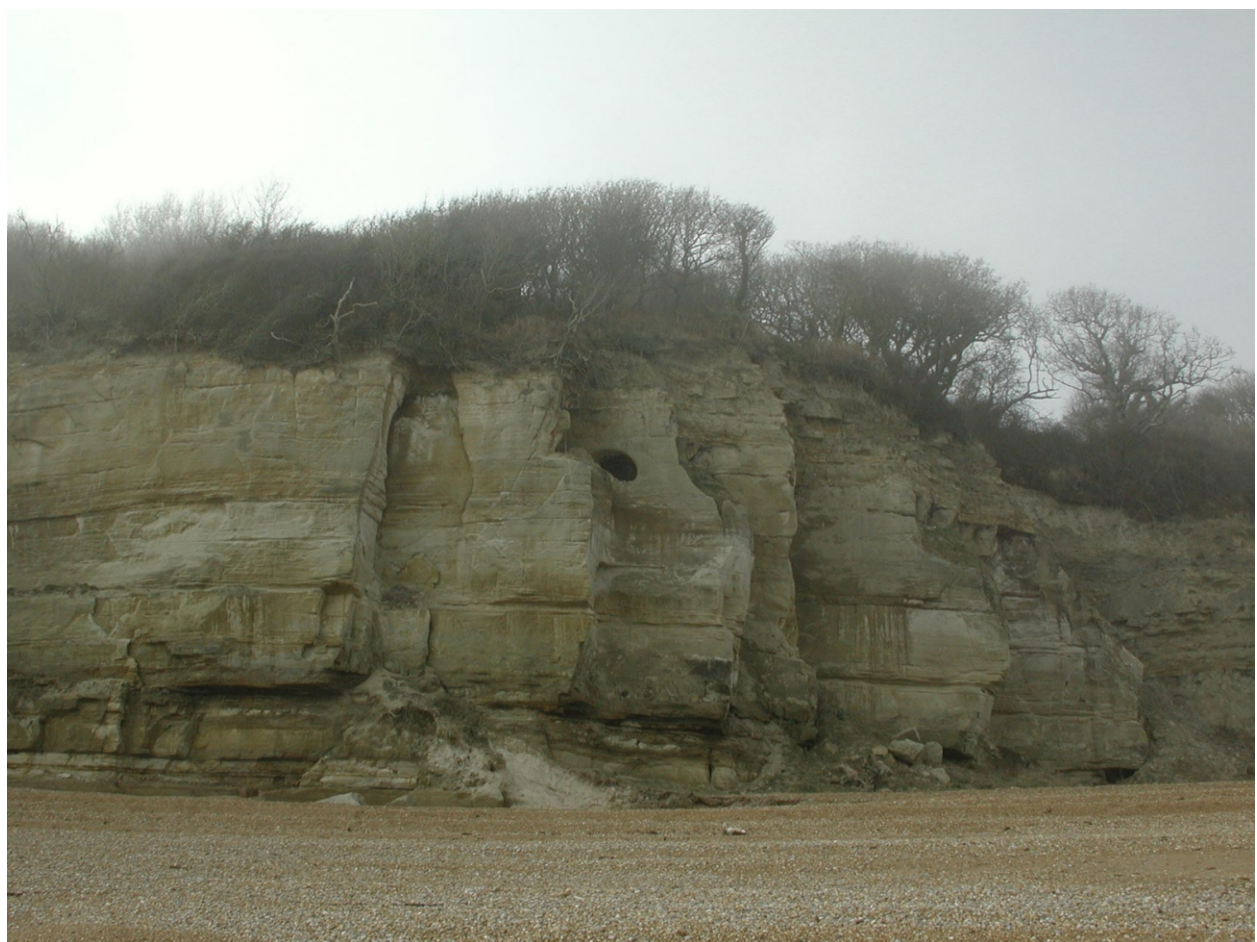
Plate 2. The late Palaeolithic or Mesolithic cave in the cliff face at Cliff End (NTSMR 129637).

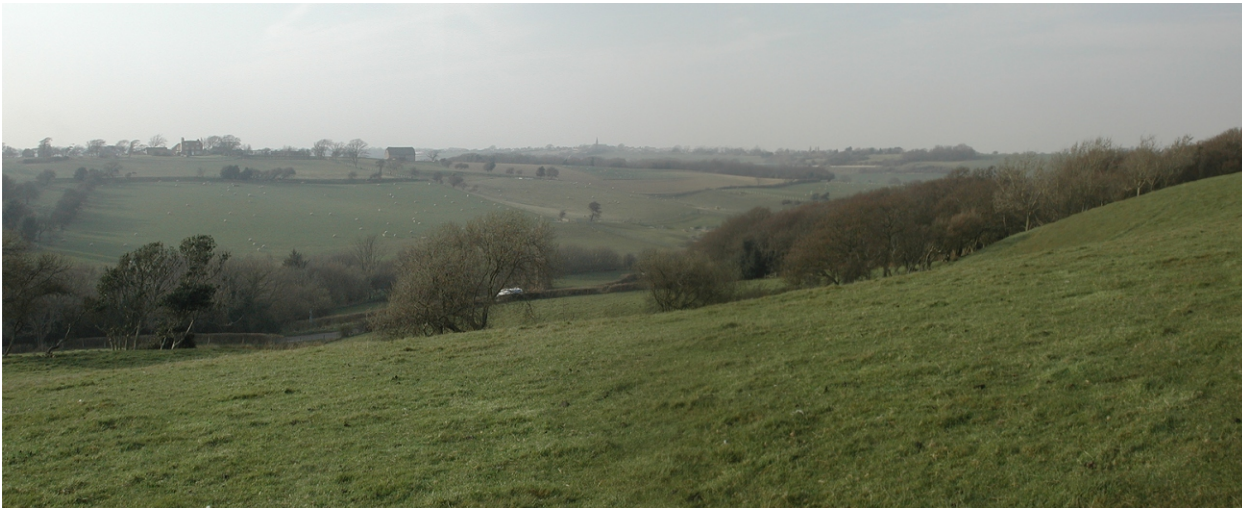
Plate 3. Panorama northwest from Fairlight Hill with Marsham Farm on hilltop to left, Old Marsham Barn (NTSMR 129667) in the centre and the village of Pett to the right on the skyline. In the foreground is the lynchet (NTSMR 129660).

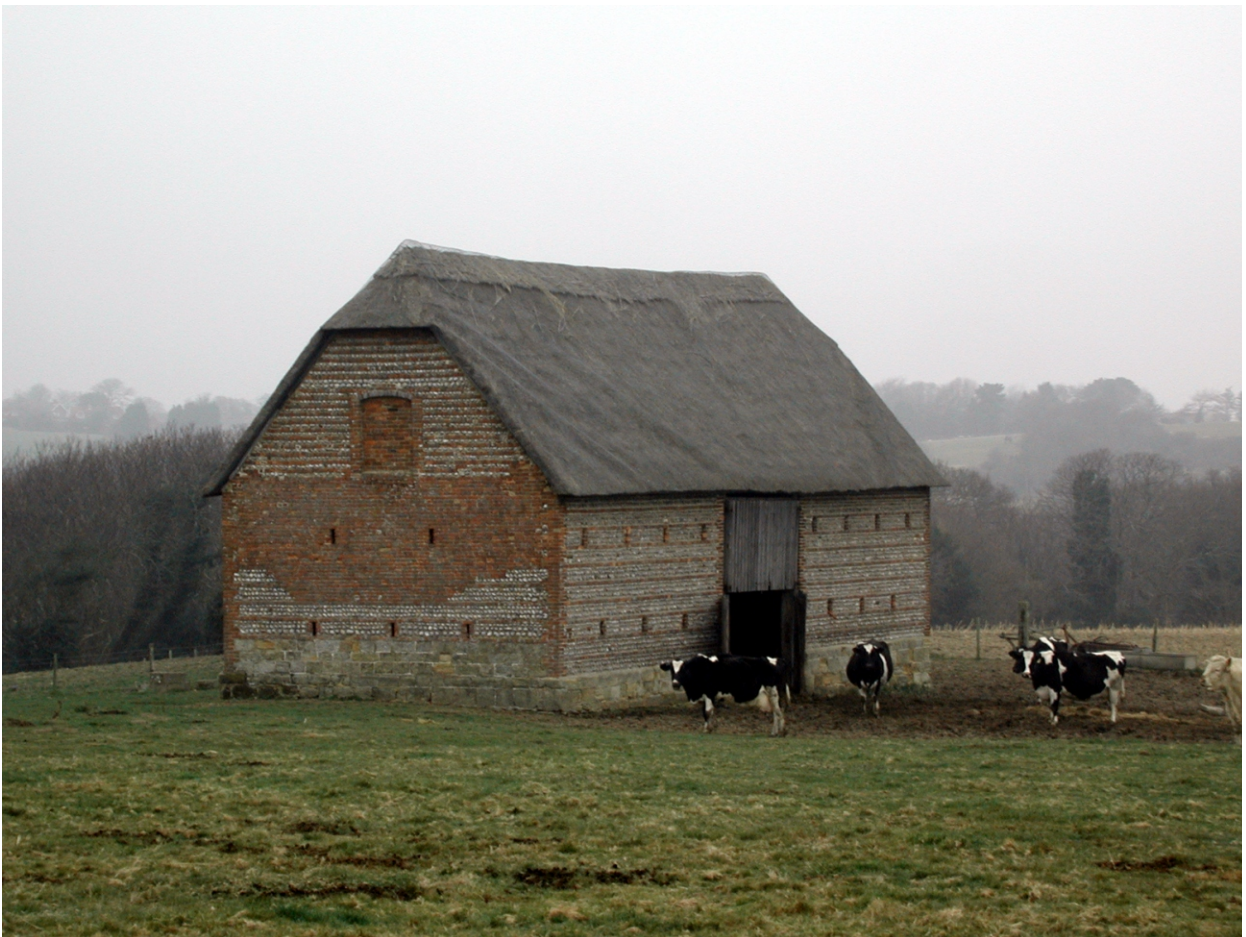
Plate 4. Old Marsham Barn from the south-east (NTSMR 129667).

Management Recommendations: Maintain building as present. Prior consultation with NT and HBMC necessary before any alterations or repairs. Vernacular Building survey to be undertaken.

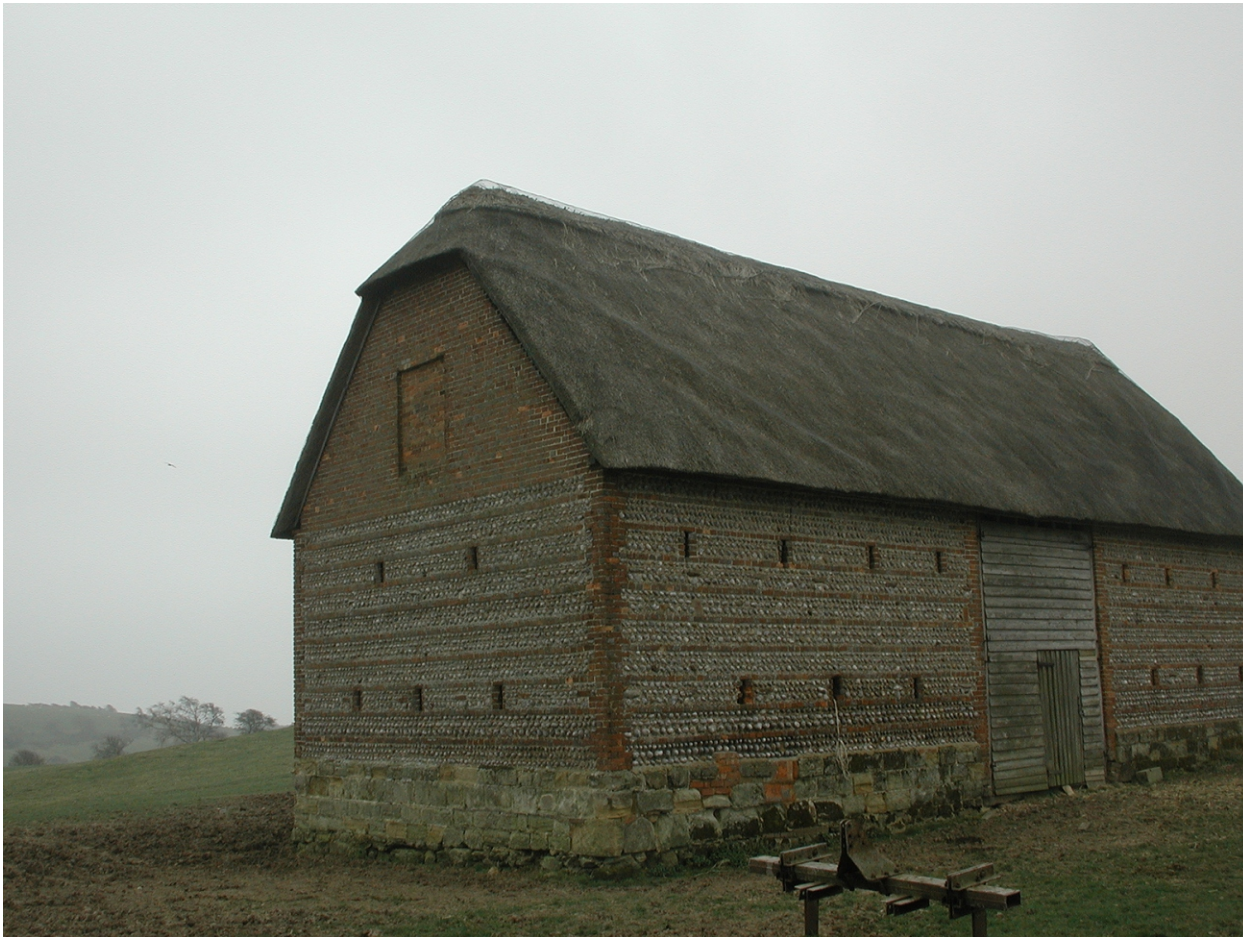
Plate 5. Old Marsham Barn detail of construction, north-western corner (NTSMR 129667).

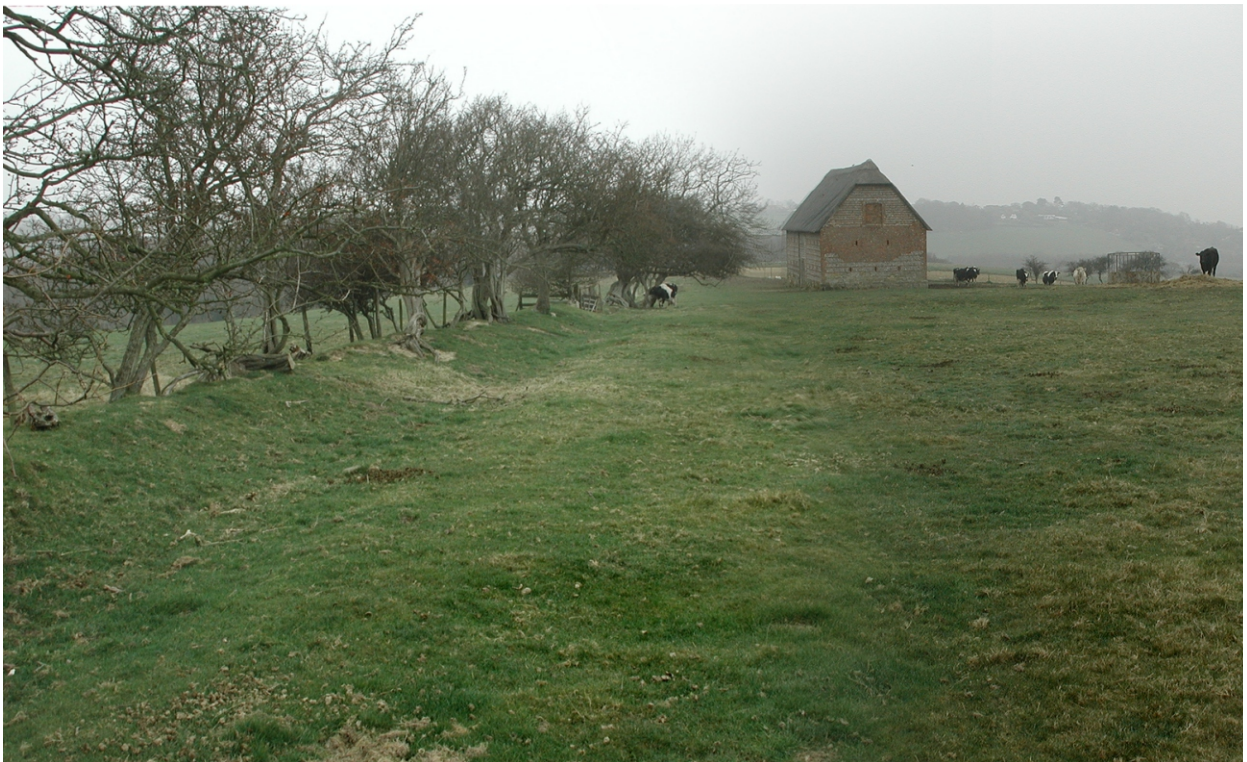
Plate 6. Old Marsham Barn from the south-west with, in the foreground, the old hedgeline (NTSMR 129666) on the west side of the field.

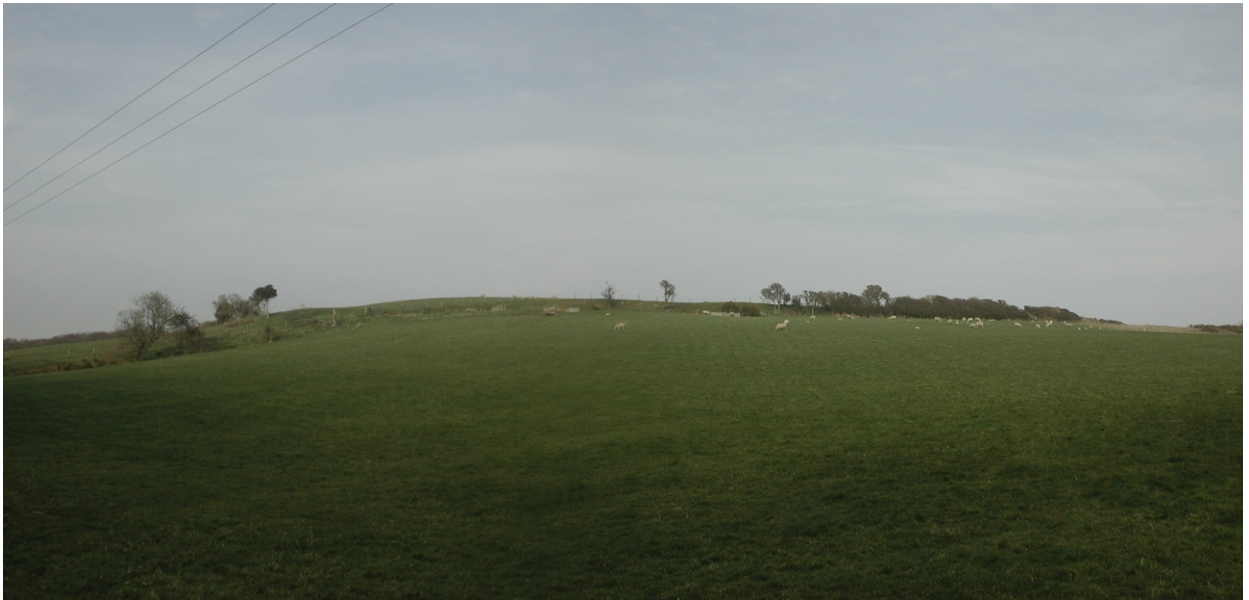
Plate 7. Fairlight Hill from the south-west showing boundary of fields on line of geological fault and, to west, lynchet on western side of hill (NTSMR 129659 and 129660).

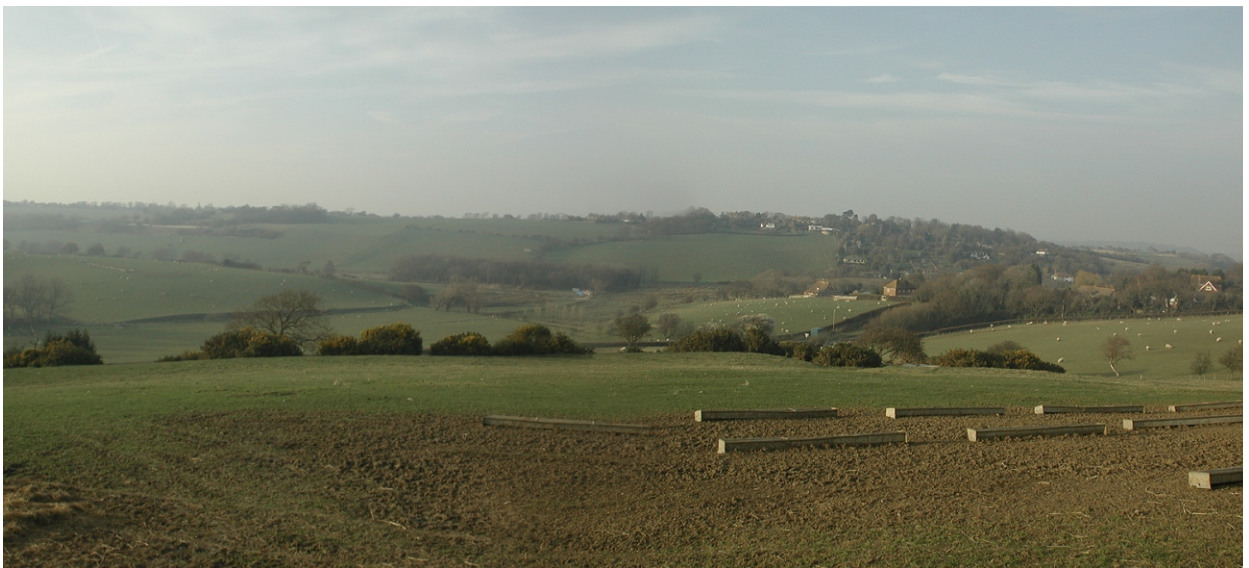
Plate 8. Panorama north from Fairlight showing valley of Marsham Sewer with Old Marsham Farm in the centre. In the foreground is field boundary and lynchet (NTSMR 129662).

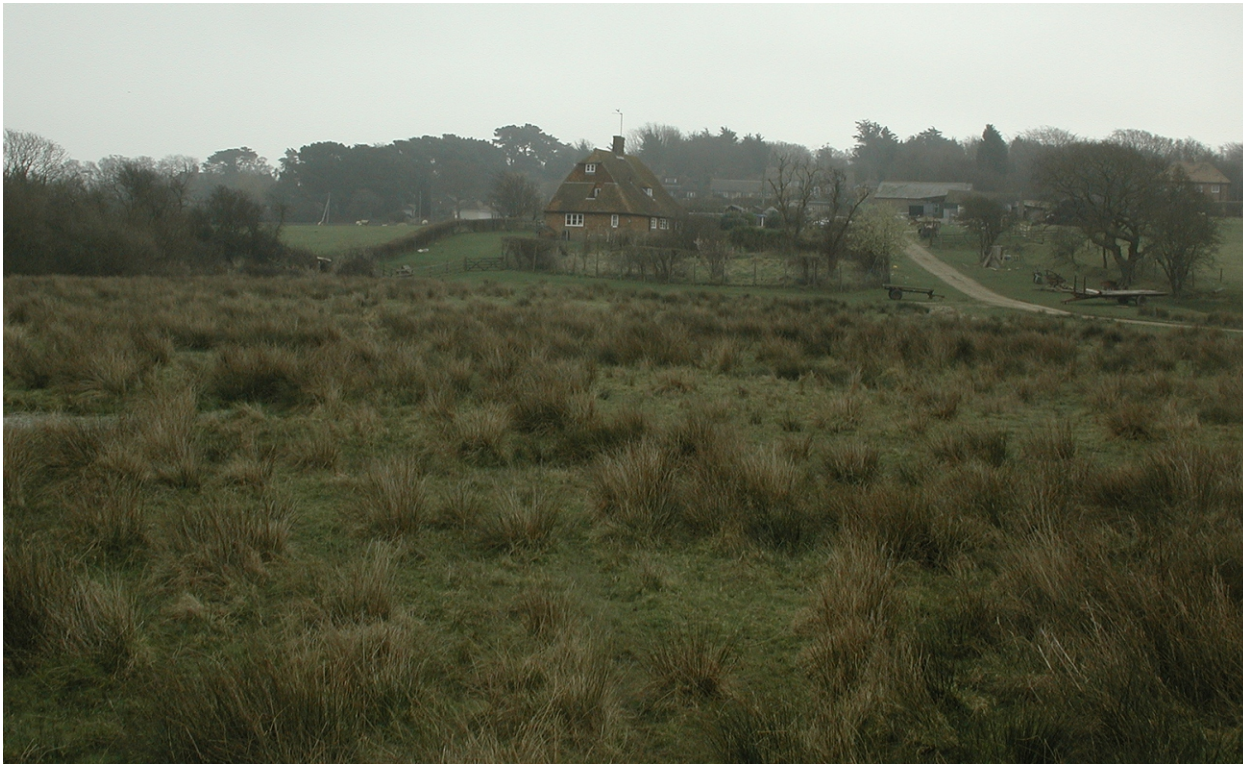
Plate 9. Old Marsham Farm from the north-west, showing its location on rising ground, south-west side of the Marsham Sewer valley.

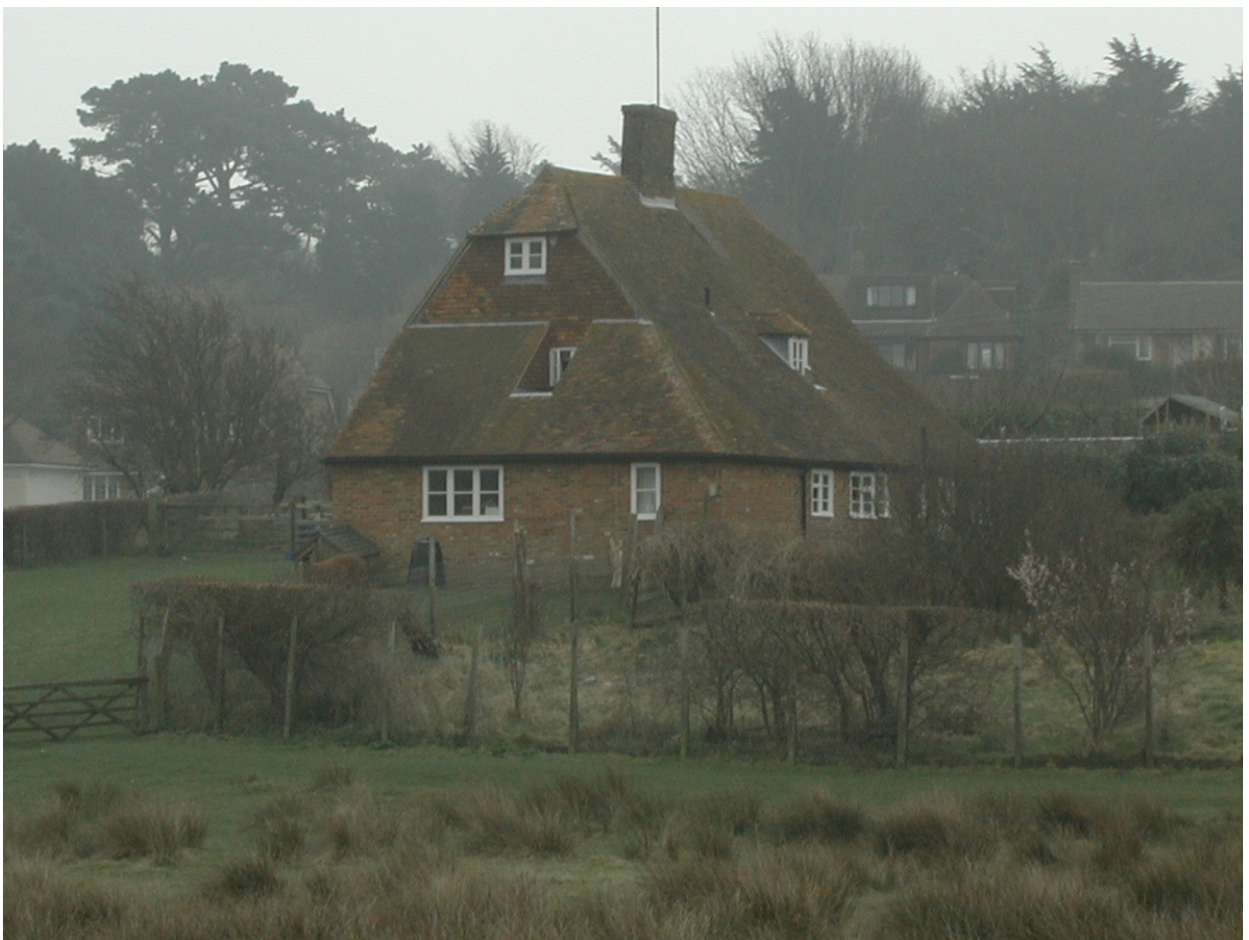
The present farmhouse is mainly a construction of c.1600, but with outshuts of c 1735 (NTSMR 129673; Plate 10). Of Timber-framed construction on stone foundations and partly clad in red brick with tile-hung upper floors and plain tiled roof, it has accommodation on three floors and a originally had a basement. The original front entrance was to the north-east with an outshut at rear. It was possibly originally a farmhouse built by Thatcher family but was thereafter altered by Thomas Medley in 1717 to serve as cottages for agricultural labourers and their families, dependent on Marsham Farm.

Field 100 'Old Marsham' 2 acres close around farm house 1839. Timber-framed farmhouse on stone foundations, partly clad in red brick with tile-hung upper floors and plain tiled roof. Two storeys, attic and basement (now blocked?). Original two-cell entry lobby on north-east front with present main entrance to continuous outshut at rear. The main building c 1600, the outshut of c 1735, with later rebuilds. The fenestration, at least, has been altered since the NT building survey of 1989. Half hipped roof with gablets and central brick chimneystack, the roof continuous over the rear outshot. Near regular fenestration on front of two light, off centre single light and three light wooden casements on each floor, boarded and ribbed door at left centre. Single casement at first floor to rear, two casements in northwest gable. Basement access from exterior on north-west but now blocked.

Plate 10. Old Marsham Farmhouse (NTSMR 129673), detail from the north-west.

Management Recommendations: Maintain building as present. Prior consultation with NT and HBMC necessary before any alterations or repairs. Existing Vernacular Building survey to be revised.

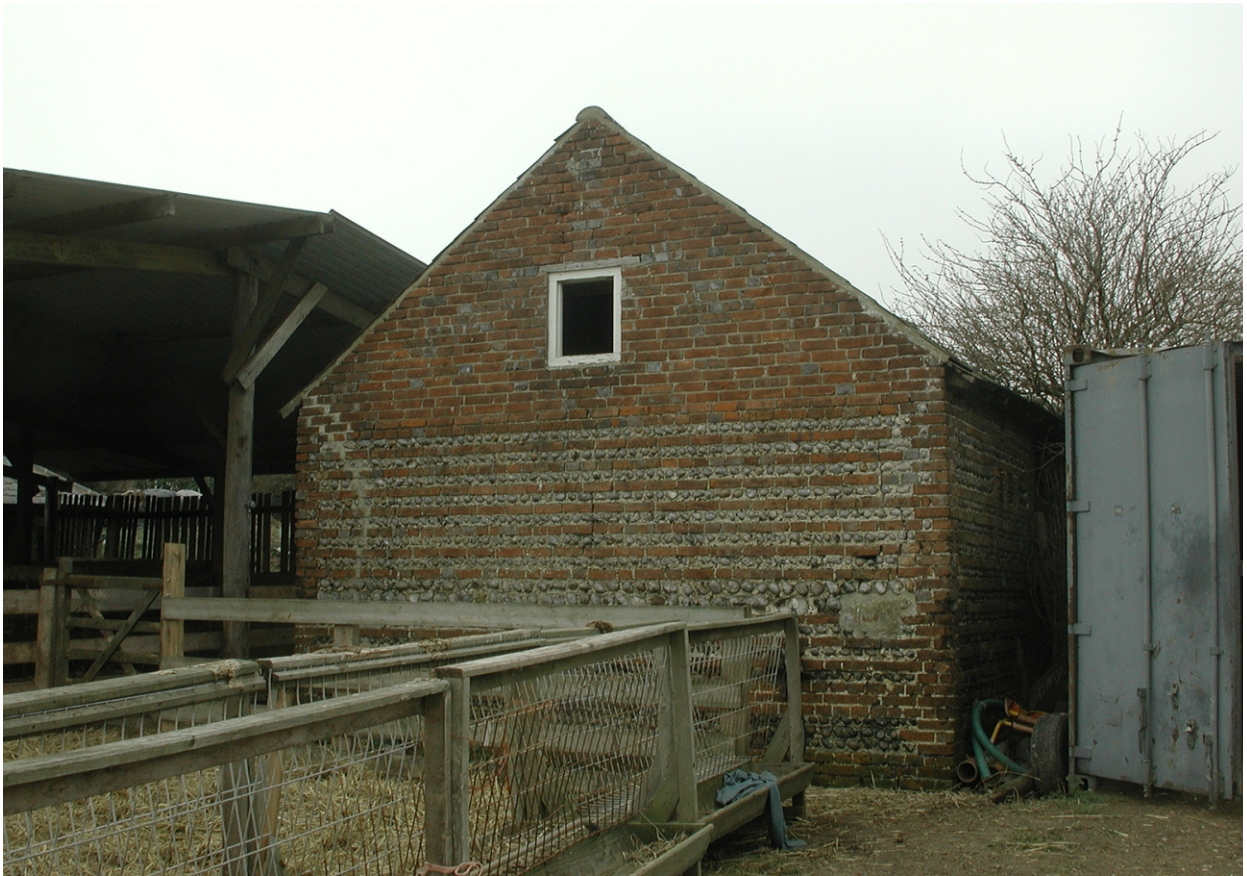
Plate 11. Old Marsham Farm, Sheephouse/calfhouse (NTSMR 129675) from the north-east, showing construction.

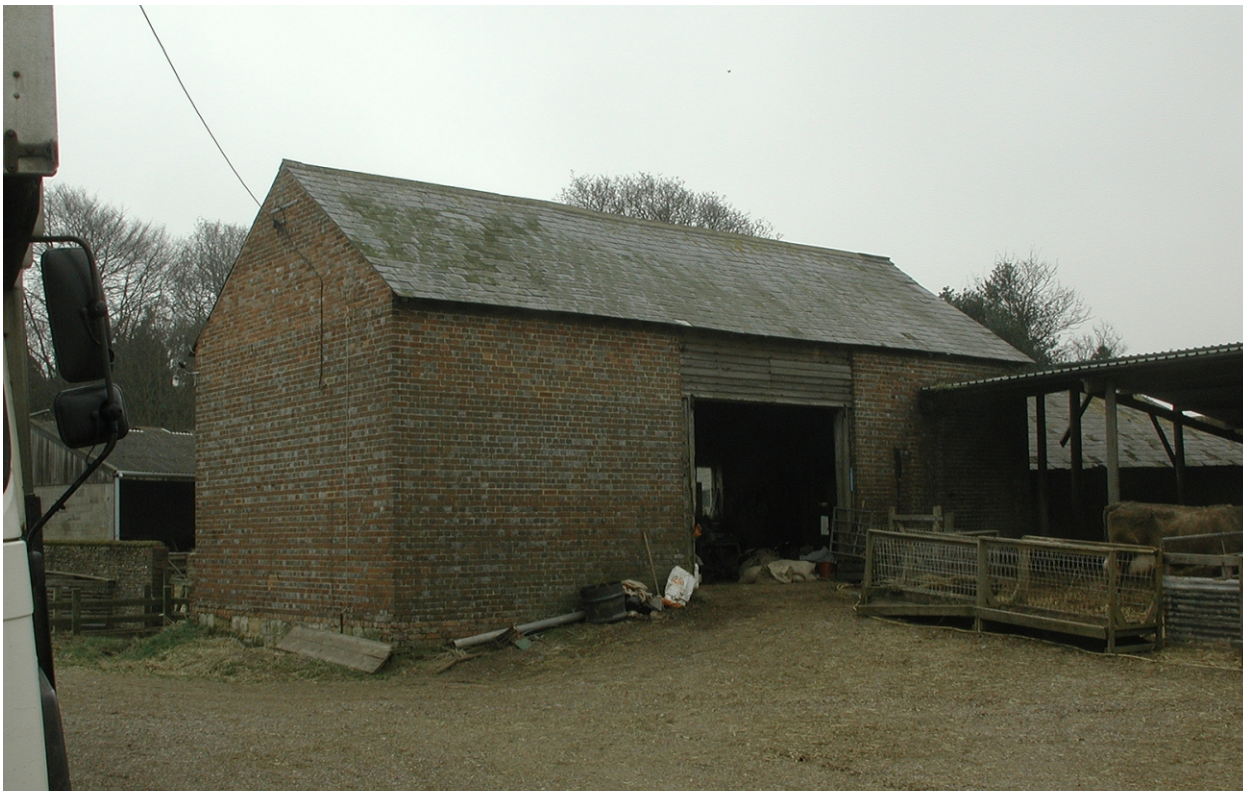
Plate 12. Old Marsham Farm, the Barn from the north (NTSMR 129674).

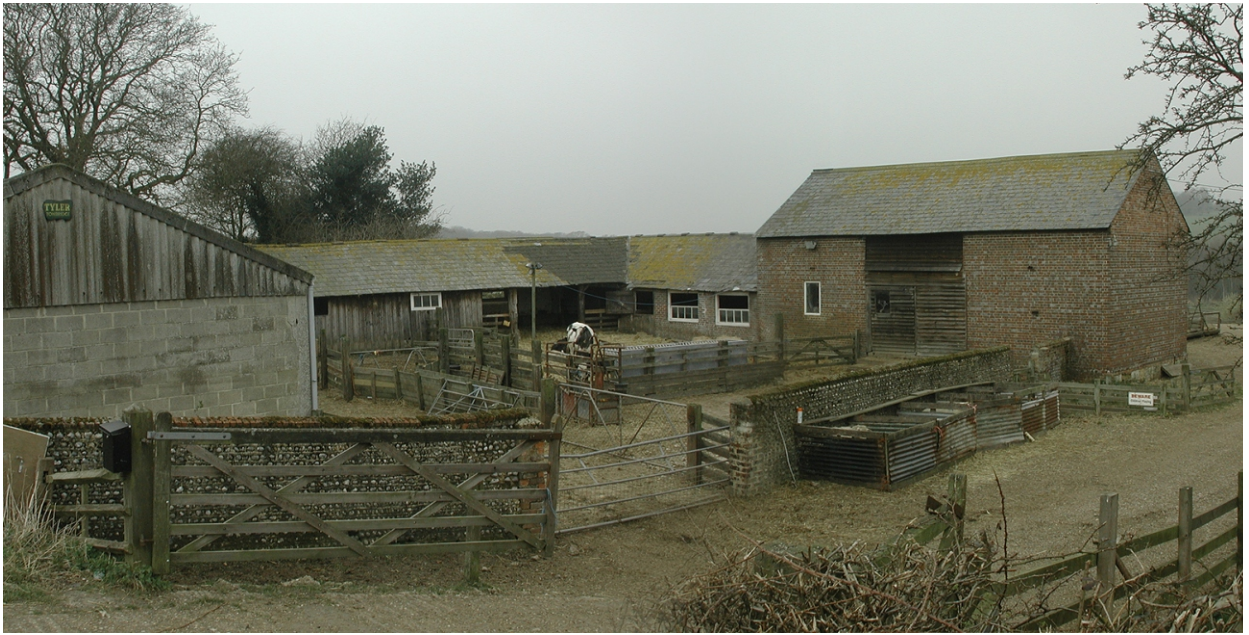
Plate 13. Old Marsham Farm, the farmyard from the east. On the left, the modern Tyler Barn, beyond the cattle sheds and the main barn on the right (NTSMR 129674, 129677 and 129678). In the foreground is the brick and flint stockyard wall (NTSMR 129676).

In the post-war period there was new construction at Marsham Farm, a Dutch hay barn, a garage, Tyler barn being erected close the road (Plate13).

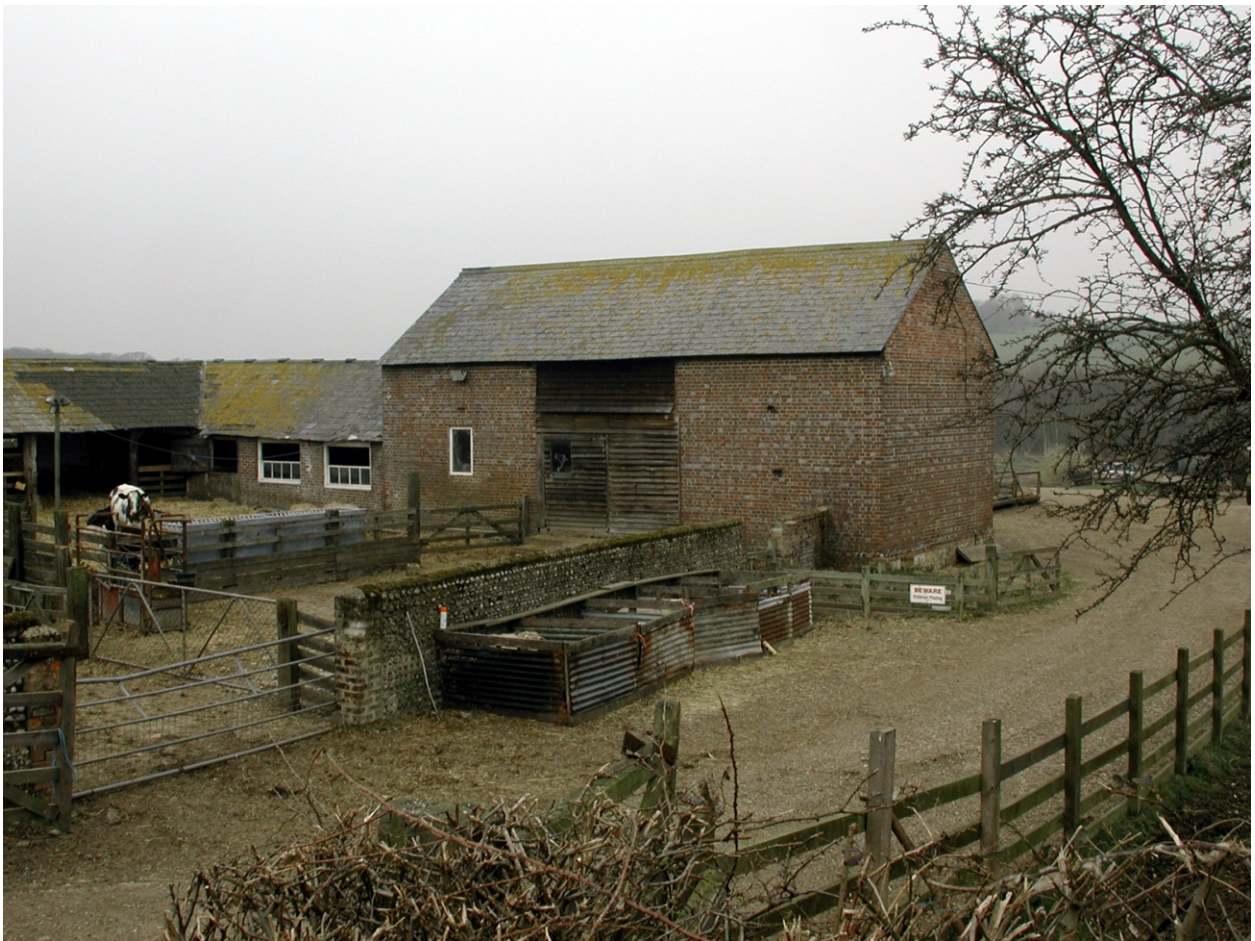
Plate 14. Old Marsham Farm, the Barn from the east (NTSMR 129674).
